August 2, 1996

Demonstration of Lead-Based Paint Removal From an Historic Wood Structure Using Laser Technology

Sponsored by: Environmental Management Division, Kelly Air Force Base, and U.S. Army Corps of Engineers, Fort Worth District

Performed by: U.S. Army Construction Engineering Research Laboratories

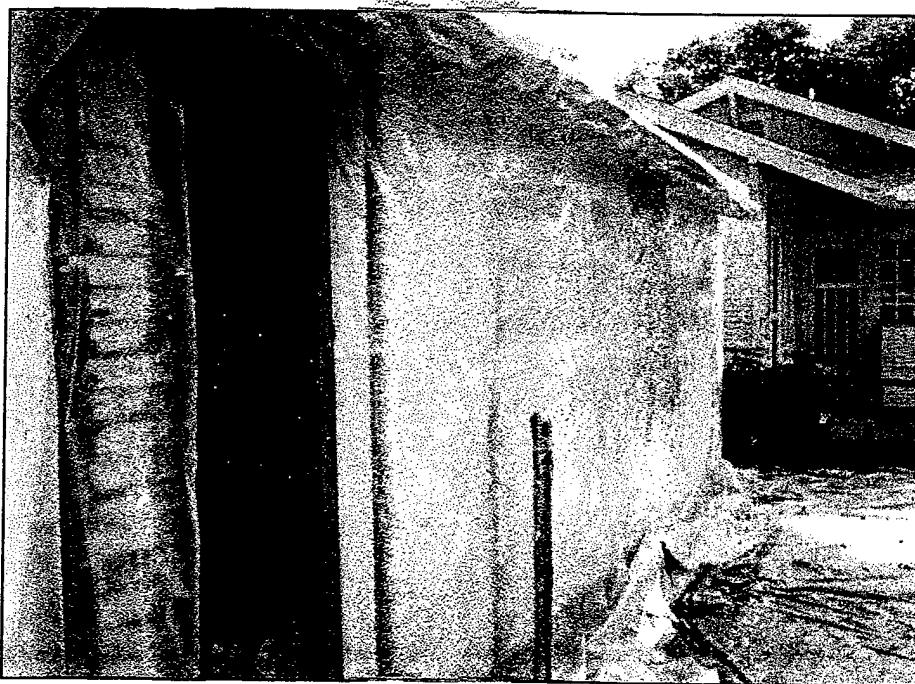
Figure 4. Containment for Chemical Stripping on Building 139

Before initiating chemical stripping on the exterior of the building, ground tarpaulins and six mil flame retardant polyethylene sheets were laid down to protect the soil from lead-based paint and/or chemical stripper contamination. Two layers of 20 by 100 foot six mil flame-resistant polyethylene sheets were affixed to the foundation of the building a few feet up from the soil level so that they covered the foundation of the building and extended 15 feet out. Barrier tape and signs were posted in and around the site and on the exterior door. A portion of a fence surrounding the project site was removed in order for the required work to be performed. The containment is shown in Figure 4. The time required for construction of the containment system was approximately two hours for the laser system, and one working day for the chemical stripping.
